MARINE INVESTIGATION REPORT

M00W0220

COLLISION

PASSENGER/VEHICLE FERRY *SPIRIT OF VANCOUVER ISLAND*

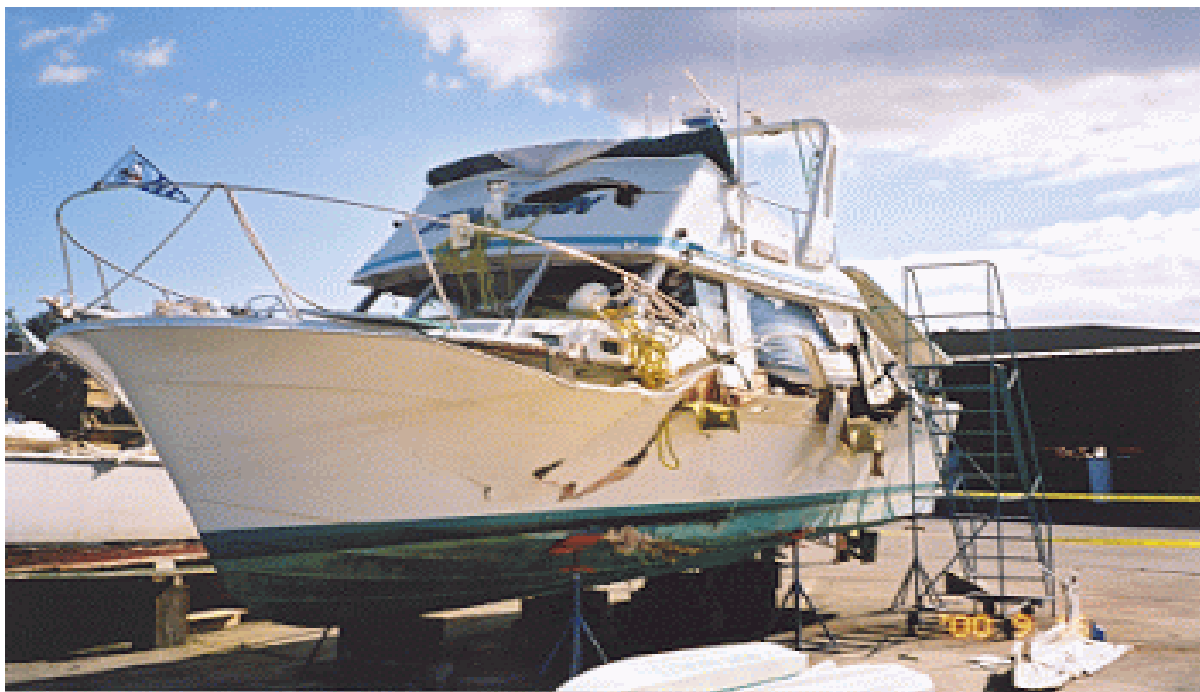
Photograph 2. *Star Ruby*

The *Star Ruby* sustained major damage. The port side of the hull, forward of the beam and above the waterline, was significantly fractured and torn away, found hanging only from its forward edge. The port aft portion of the superstructure was torn away, leaving a gaping opening into the cabin. Below the waterline, between the port chine and the keel, the hull was gouged and torn open as a result of contact with a scupper pipe extending from the hull of the *Spirit of Vancouver Island* adjacent to the starboard anchor pocket. There was no discernable pollution.
